NMEC - SEMINAR
ENERGY EVENTS CENTRE

Roydon Gilmour – Technical Account Manager ANZOR Stainless Steel Ltd.

PREN – PITTING RESISTANCE EQUIVALENT NUMBER

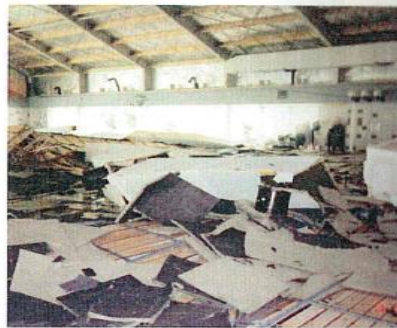
Figure 1: 1 June 2001, the morning after the collapse of ceiling and air channel in the indoor swimming pool at Steenwijk (NL). The collapse was caused by environmental cracking of stainless steel threaded bars. (Photo courtesy: Steenwijkerland municipal).

This paper is mainly based on my personal experience with technical inspections in Dutch swimming pools. In the Netherlands every town or village has one or more public swimming pools. About 700 large swimming pools are owned by authorities such as municipalities and at least 1500 smaller public indoor swimming pools are owned by hospitals, revalidation centres, schools, hotels, camping sites and the recreational sector. As a corrosion specialist, I was involved in this subject in 2001 when the entire ceiling and air channels collapsed in a swimming pool in Steenwijk (the Netherlands) [2]. As you can see on figure 1, this luckily happened during closing time.

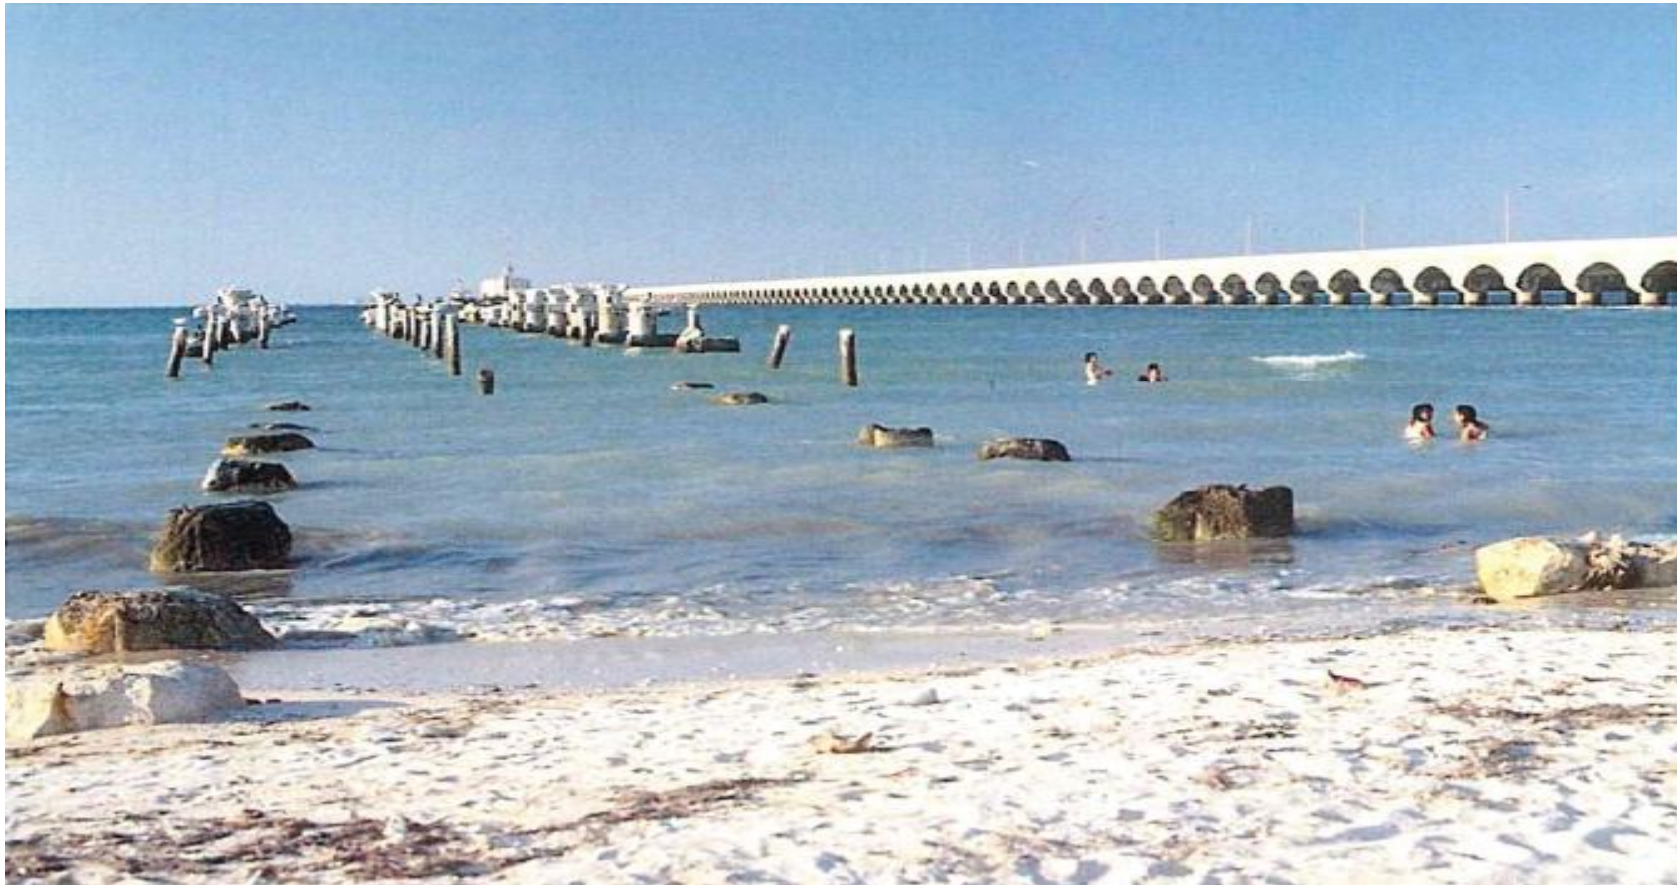
Pier in Mexico – 70 years old used 304 Grade Stainless Steel Reinforcing Bar in poorly placed low quality concrete is still operating.
A replacement Pier built alongside using Carbon Steel Reinforcing lasted 11 years.

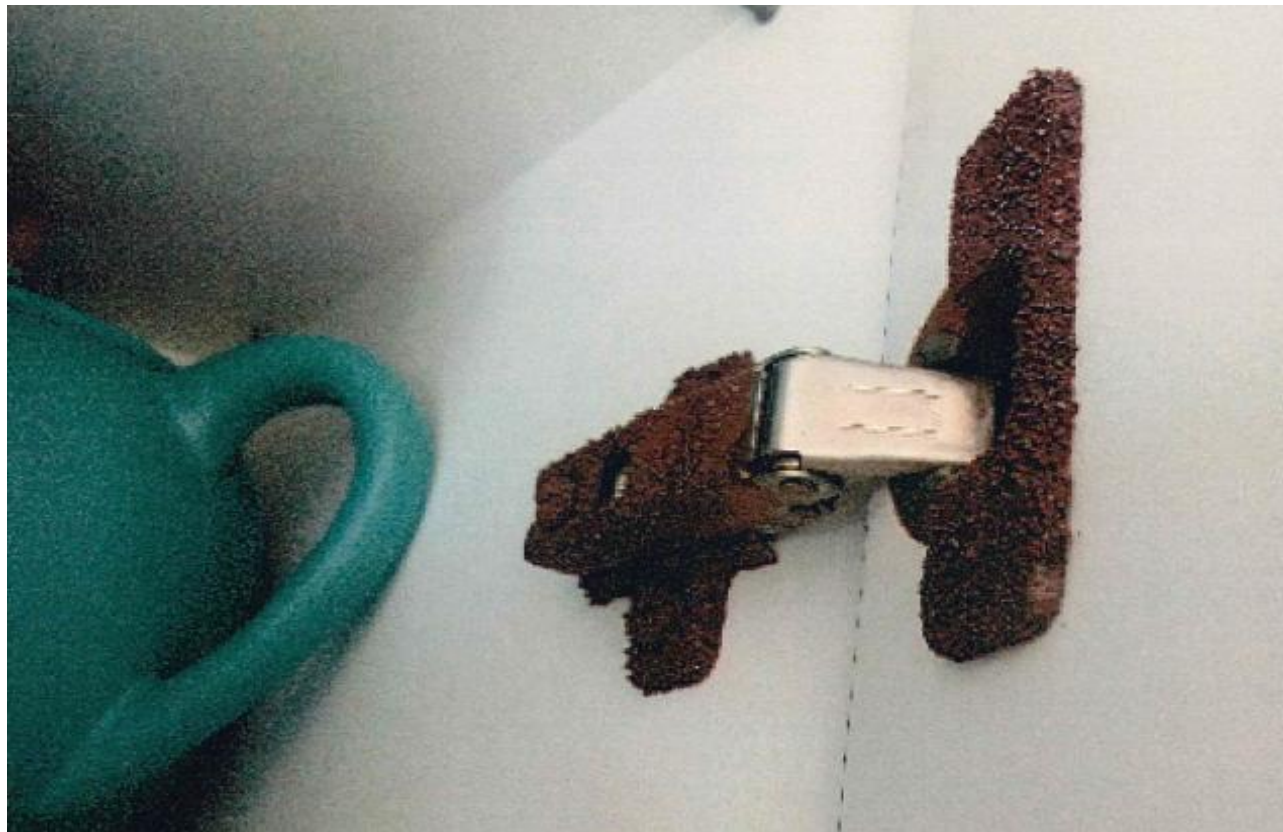
316 Grade Screws used in Boardwalk at Maldive Islands – Crevice Corrosion,

304 Grade hinge in a cupboard at Piha corroding badly – an open bottle of a Chlorine based cleaner.

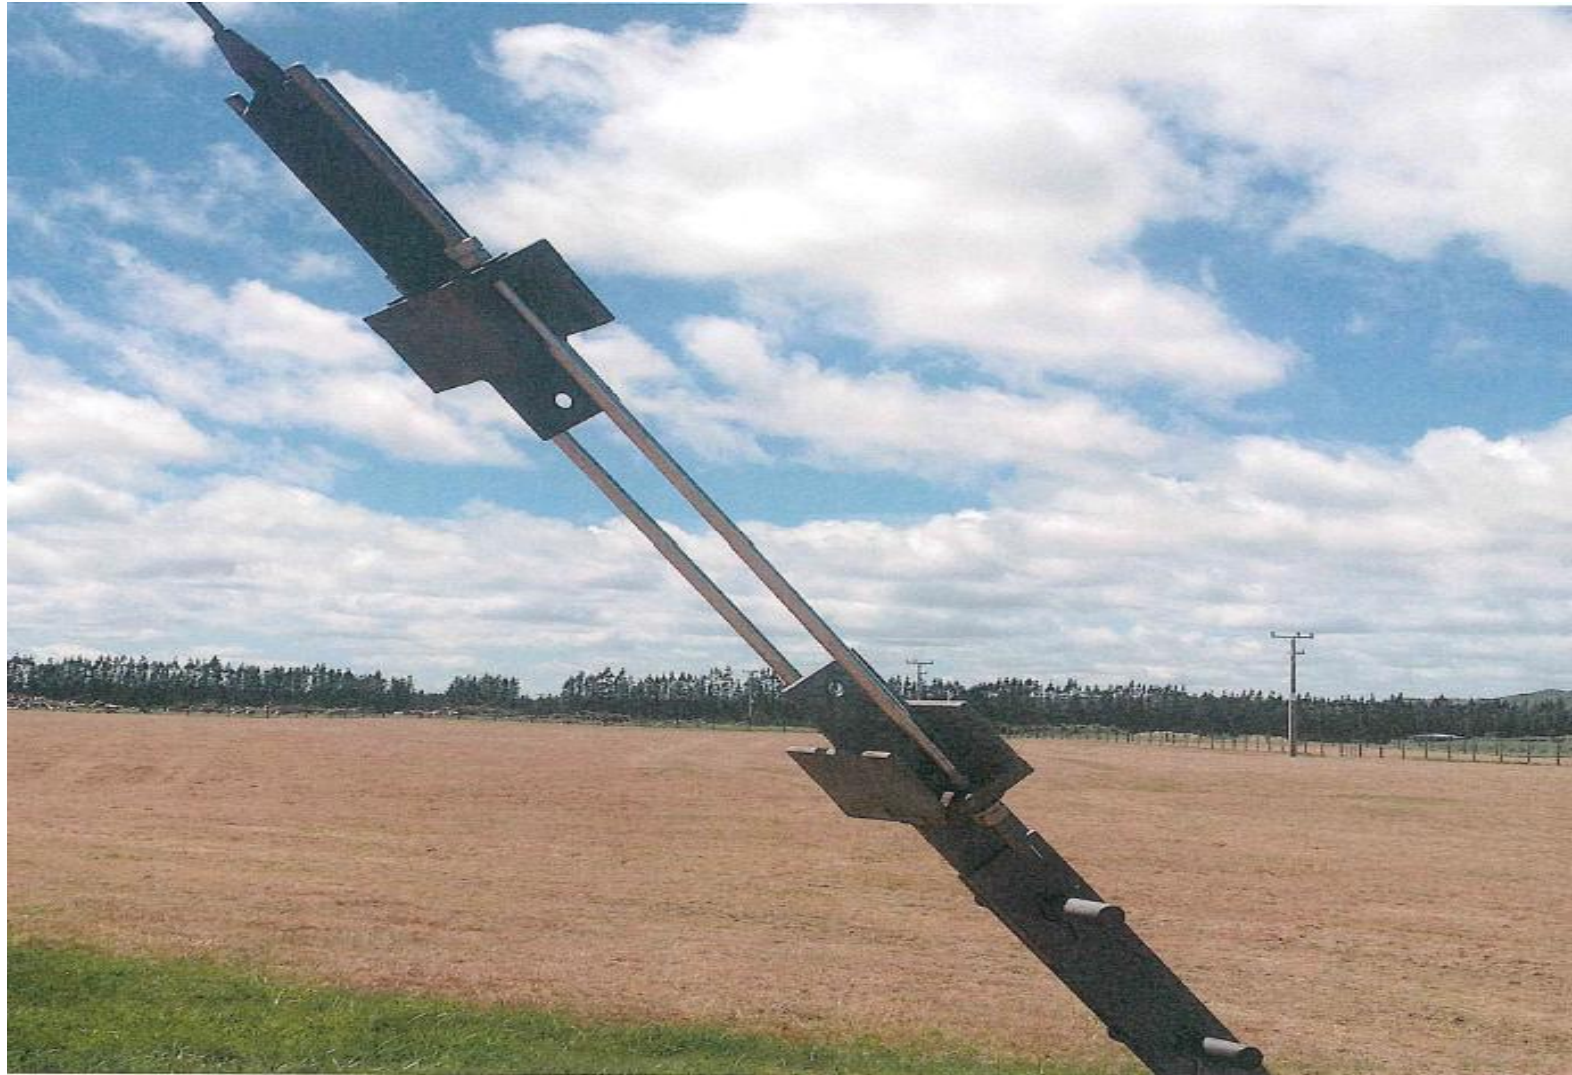
Duplex Grade Tensioners for NZ Radio Aerials – note the use of Tefgel.

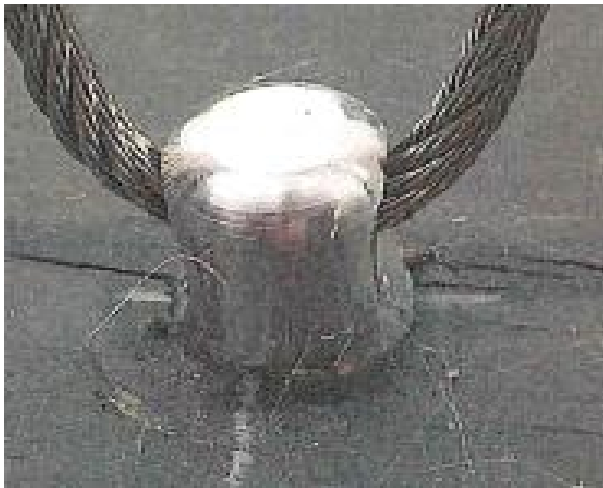
Carbon Steel Contamination and Installation matter;
Anzor 316 Grade Eyelets in Kerikeri, the Customer wrote - "It should be of no relevance how these were installed as stainless does not rust! The eyelets with the groove react to magnet (we have just discovered) which proves they are not stainless."
